RECONFIGURATION OF THE UNIVERSITY SQUARE BASED ON AN EMBLEMATIC PLACEMENT OF THE NATIONAL THEATRE

Prof.Dr.Eng. M. Ieremia

Technical University of Civil Engineering Bucharest

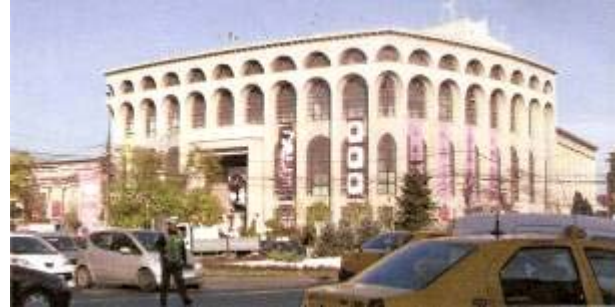
Figure 4. Structure of Section A Main Hall, following the changes made in 1983.

Following the changes made in 1983, the stress structure of Section A – Main Hall – was fundamentally changed (Figure 4), fully ignoring the technical legislation in force at the time, and with even less concern for the present day requirements of designing codes.

As such, the Main Hall was extended by removing the curved fan-shaped structural walls (four of the eight reinforced concrete diaphragms being removed), various areas were torn down or reshaped locally, in order to make way for the official box lobby (in an atypical position, by

special request from the state leaders of the time); exhibition spaces were created, using the terrace over-flooring method (at levels 4 and 5); a new facade was built, in the shape of a high portico, in front of the original roofing, and this facade added a significant, inadequate load on level 2 of the nearby parking lot, and so on.

That is why it is paramount to revert to the initial parameters of the stress structure, conforming to in force technical standards (but also to the standards which were valid at the time of the 1982 elaboration of the project that aimed at extending the theatre capacity).

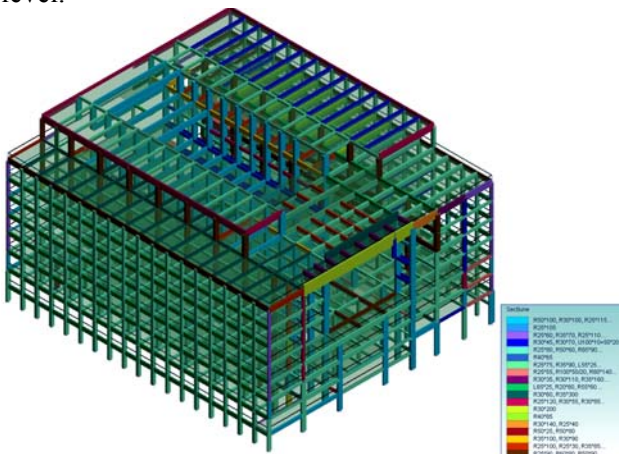
Figure 5. Structural model of Section B The Annexes

The technical assessment made in December 2006 analyzed the effects of the earthquake on the stress structure of the National Theatre assembly, by comparing standards (seismic design codes) elaborated in 1963, 1992 and 2006 respectively, and reaching the conclusion that consolidation works should mainly concentrate on the elements of Section B (the Annexes) – Figure 5. The frame type structure, which does not comply with para-seismic requirements, in the absence of continuous flooring at each level, as well as the initial design, which did not take into account the specificity of conventional seismic forces from the Vrancea area – all these were as many major arguments in favour of the decision to consolidate this building section with the help of a flexible structure with a high vibration range. There are no seismic protection expansion joints between the buildings, the existing one being just a dilatation joint. That is why the building of Section B had to be stiffened in the end areas (corner areas), in the vicinity of the other sections.

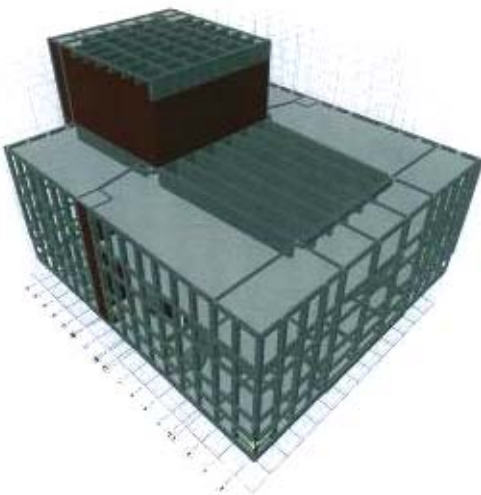
Figure 6. Structural model of Section C Studio Building.

Section C – Studio building (Figure 6) – largely lacks seismic protection, especially in its cross section.

Also, the specific vibration of this unconsolidated building determines extremely dangerous assembly torsion combined with translation movements on both directions, thus

proving its unreliability in the case of seismic action (Figures 7, 8, 9). The building structure must undergo consolidation at stress structure and rigidity level.

Taking into account all of the above, the consolidation works of sections B and C must be made during the same stage (simultaneously), and the site premises must be organized accordingly - Figure 10.

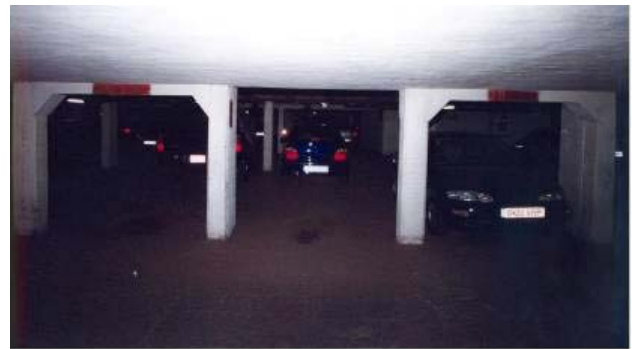
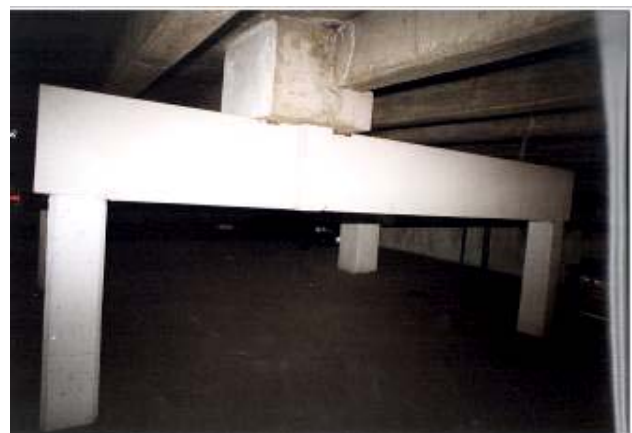
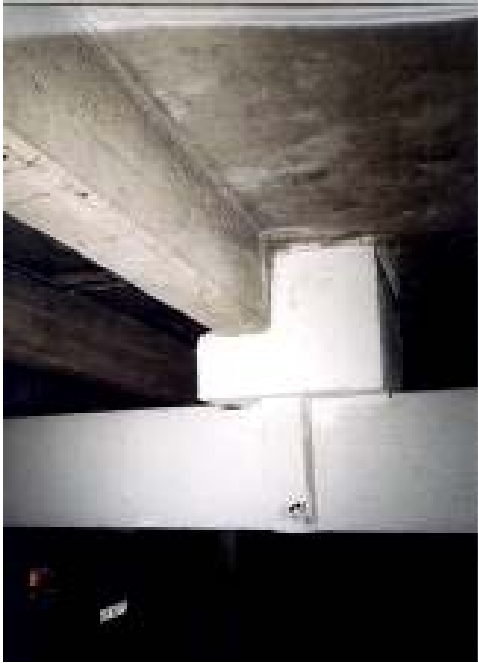
An unfortunate example is given by the existing support system for the over-floored terrace pillars, using statically determined beams in the cantilever. Also, vertical breaks (pillars on beams, beams on beams) determine a deflection of loads, but also certain sudden changes of the rigidity and

Therefore, the portico pillars are placing a significant pressure on the flooring over the underground parking lot (Figures 11, 12, 13), and this area, in which the load is transferred from one building to another, is a danger zone from the point of view of the required security level, against permanent static gravity action, as well as against lateral and vertical dynamic, random actions.

The dismantling of the existing facade, made in 1983, will reduce the extra load exerted on the parking ceiling by the theatre facade and the subsequent over-flooring, while the roof from the main entrance will be displayed in its original form of 1968.

In order to increase the existing capacity of the parking lot and to redistribute loads across its stress structure, supplementary beams made of reinforced concrete will be mounted, observing the existing height limits.

Further on, the pillars supporting the parking lot will be coated – on their entire surface – in order to work jointly with the newly created cross beams.
