BULETINUL INSTITUTULUI POLITEHNIC DIN IAȘI
Publicat de
Universitatea Tehnică „Gheorghe Asachi” din Iași
Volumul 64 (68), Numărul 2, 2018
Secția
CONSTRUCȚII. ARHITECTURĂ

CHARACTERIZATION OF THE SEISMIC ZONE OF CHIȘINĂU

EVGHENI CUTIA*

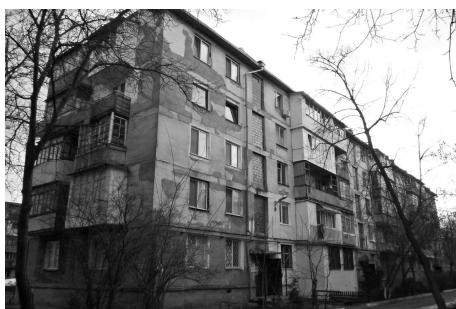
Fig. 1 – Building series 1M-438AC (GeoPortal, 2018).

a) project for stone buildings series 1-311C, 1M-438AC, 102SC (Fig. 1);

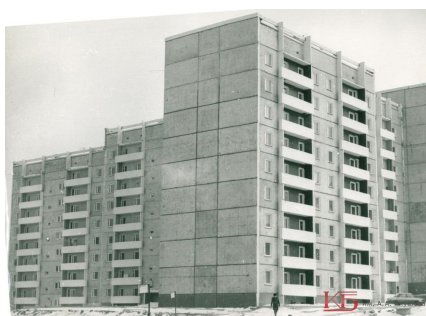
Fig. 2 – Building series 135 (Vostochno-Sibirskoe Konstruktorskoe Bjuro, 2017).

b) project for large panel buildings series 1-464S, 1-464AS, 135, 143, 143MK, 92MSB;
